**RM03-00001 CODE: D DD: A**

**DEC-O-LOG**

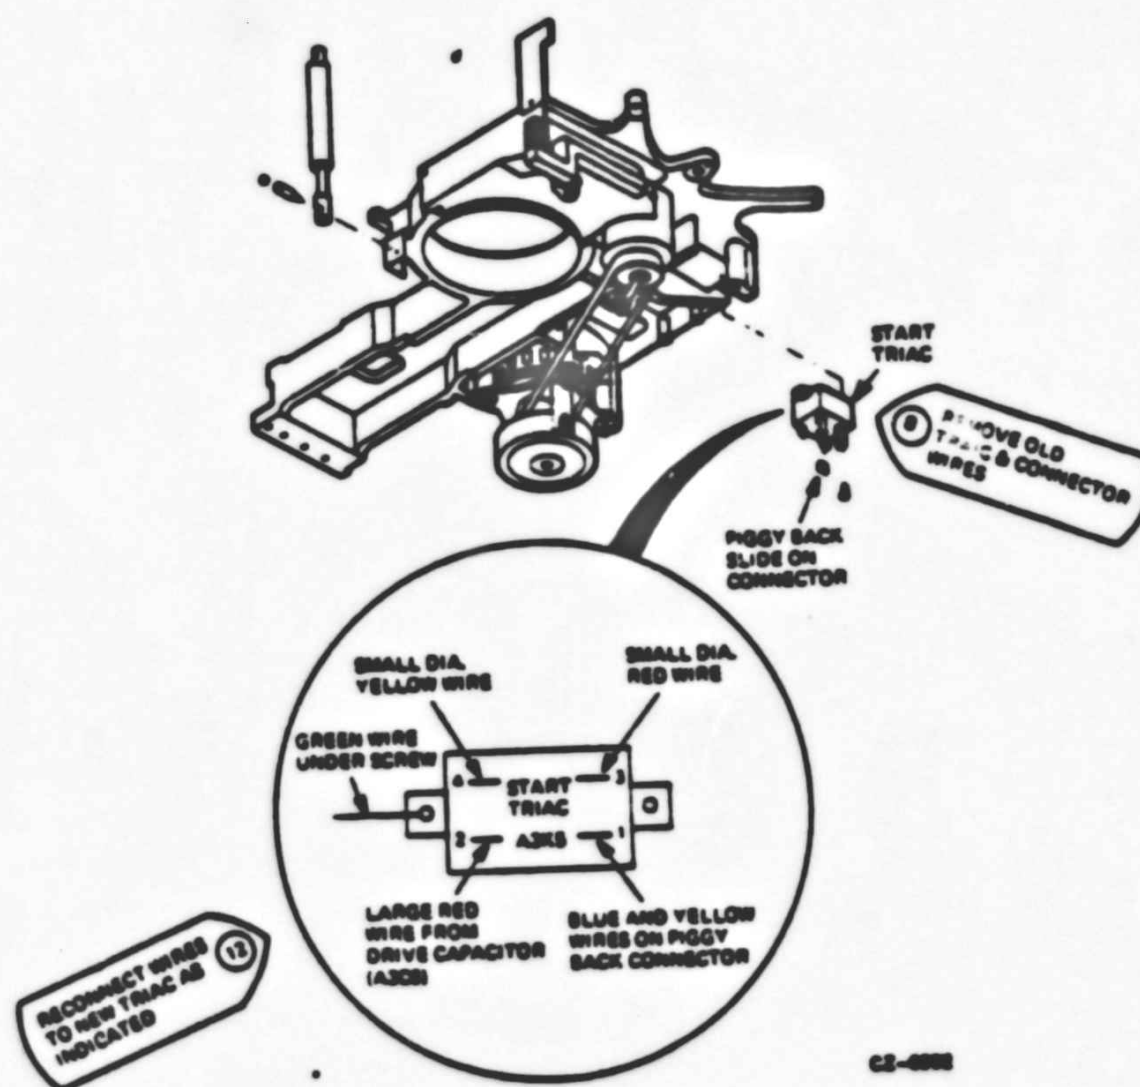
Figure 2 Start Triac A3K5

Failure/Symptoms: Possible start relay failure due to peak inverse voltages in excess of device rating.

This FCO replaces the existing 600 vclt A3K5 Start Triac (CDC P/N 94376501) with an 800 vclt Start Triac (CDC P/N 94376503)

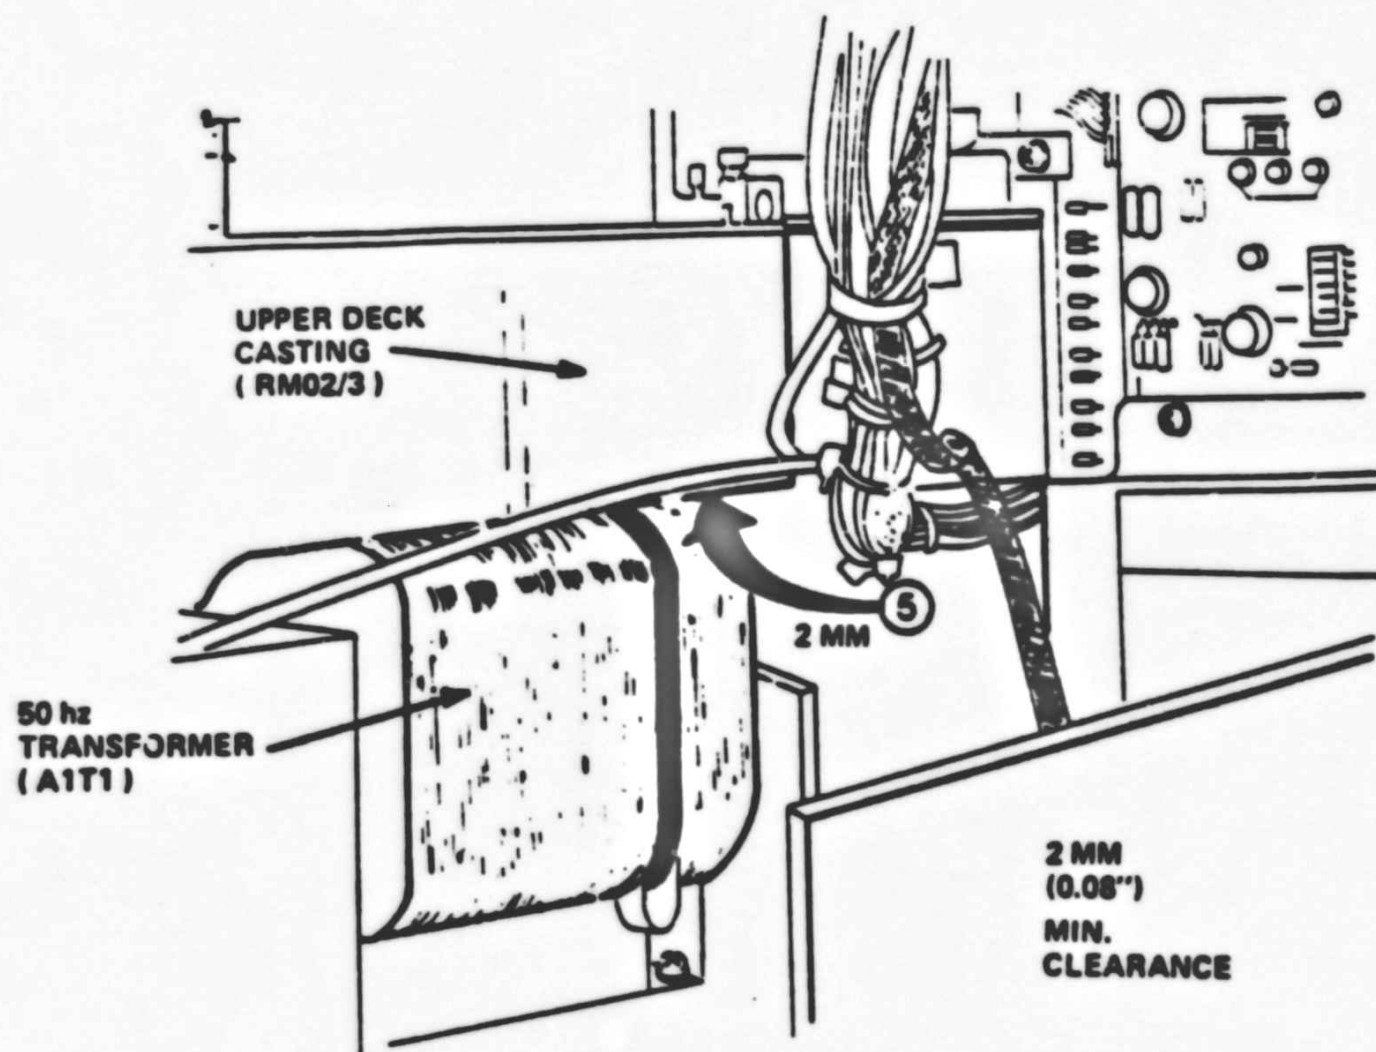
FIGURE 3

Problem/Symptoms: Transformer (A1T1) may come in contact with the upper deck plate assembly (when raised or lowered); resulting in damage to the transformer winding insulation and/or shorting of the transformer windings to the chassis.

7. Carefully examine the insulation on both sides of the transformer (transformer windings insulation) for any signs of physical damage (ie: punctures, tears, scratches, indentations, etc.).

**IF PHYSICAL DAMAGE HAS OCCURRED THIS WILL REQUIRE REPLACEMENT OF THE TRANSFORMER. GO TO SECTION 2 FOR TRANSFORMER REPLACEMENT PROCEDURES.**

8. If there is no physical damage to the AC power transformer winding insulation, check to ensure that the required clearance between the AC power transformer winding insulation and the upper deck plate assembly is 2mm (.08 inches).

9. With the deck in its lowered position, check to be sure that there is a minimum clearance of 2mm (.08 inches), between both the left and right side of the AC power transformer winding insulation and any part of the upper deck plate assembly. The critical areas of clearance are noted by the arrows labeled with no. 5 in FIGURE 3. A flashlight and feeler gauge may be required. The side of the transformer closest to the power supply assembly, see FIGURE 4, can be observed by looking through the hole in the rear of the positioner (ARROW 3, FIGURE 1) and applying sufficient light (with a flashlight) as shown by ARROW 4 in FIGURE 1. Assure that there are no pinched wire harnesses and no chance of damage due to contact between the transformer assembly and the upper deck chassis or other surrounding components.

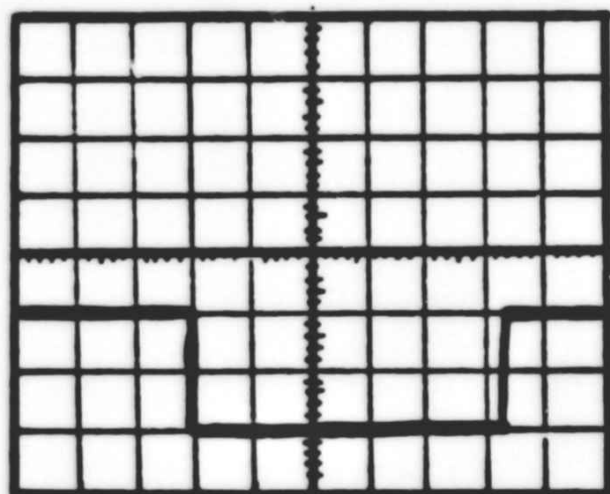
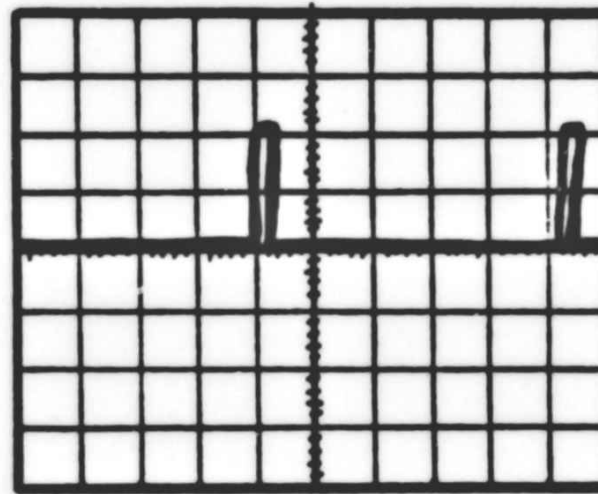
THE PICTURE SHOWN IN CHAPTER 4 OF THE RM02/03 DISK SUBSYSTEM SERVICE MANUAL (EK-RM023-SV-001) FOR THE VELOCITY GAIN ADJUSTMENT IS CORRECT. THE PROCEDURE IS CORRECT; HOWEVER, THE OSCILLOSCOPE DISPLAY COULD LOOK LIKE THE ONE BELOW IF YOU LOOKED AT TEST POINT B02-3A INSTEAD OF B09-3A.

A2B09-03A CROSS REF PAGE 193 IS "+ ON CYLINDER"  
 A2B02-03A CROSS REF PAGE 123 IS "+ (BUS) BIT 29"  
 YOU COULD ADJUST THE VELOCITY GAIN USING THIS SECOND TEST POINT BECAUSE THE BUS BIT IS RELATED TO "ON CYLINDER". HOWEVER, IT IS RECOMMENDED THAT YOU USE THE CORRECT PIN B09-03A TO PERFORM THIS ADJUSTMENT.

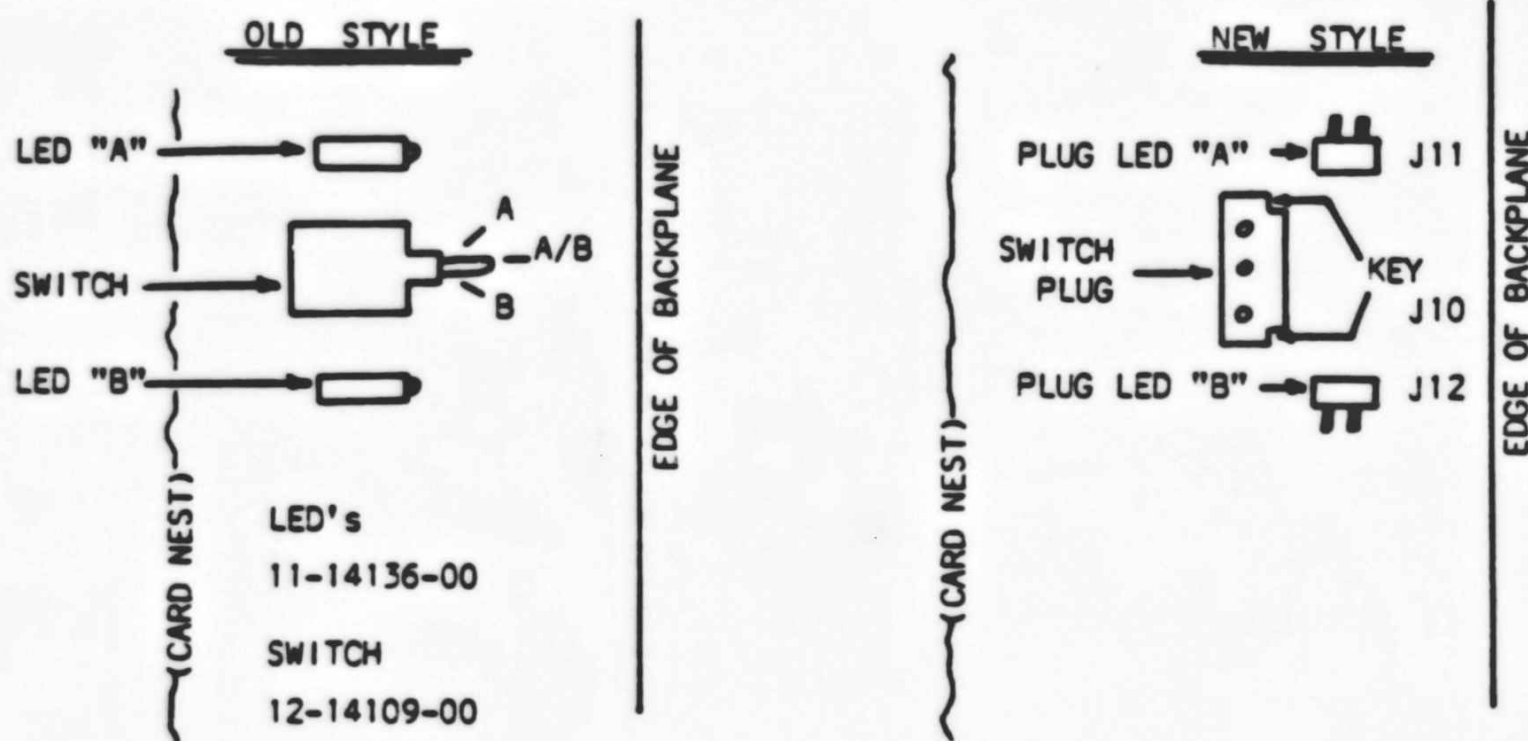
Ensure that the center plug has the keyed side towards the edge of the backplane, away from the card nest as shown below.

If the keyed part of the switch plug is facing the wrong way (towards the card nest) unsolder the plug and reorientate it correctly.

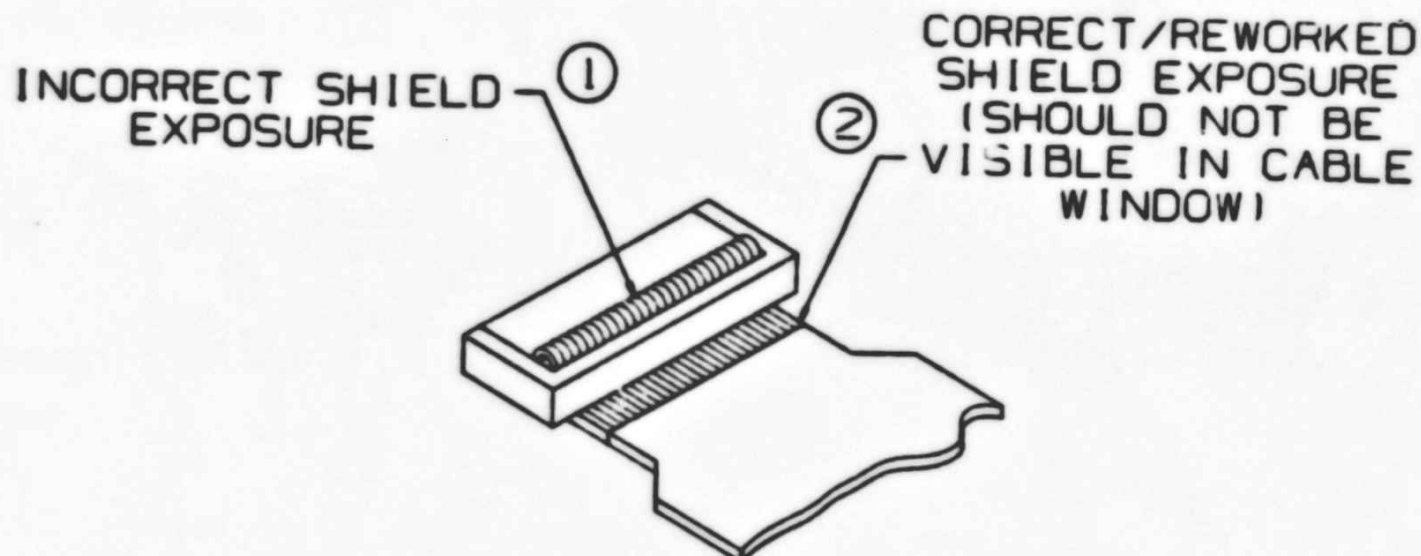
The new FCC shielded A/B cable (p/n 70-19688-15) may cause shorting to the RM05 MBA. Specifically, the end of the 26-pin "B" cable that plugs into J1 of the M7687 module in the MBA, may have "exposed" shielded braid within the cable "window" of the berg connector as shown by area # 1 below.

Cables with exposed shield in this area (#1) can cause shorting of etches on the M7687 when installed. These cables should NOT be reworked in the Field as cable damage could result. Covering the exposed area with tape is also NOT acceptable since you will only be prolonging the problem. You may tape the exposed braid on an existing cable ONLY AS AN INTERIM TO REPLACEMENT. The best solution is replacement of the cable with a reworked Rev "A" cable.
