**RM03-00001 CODE: D DD: A**

**DEC-O-LOG**

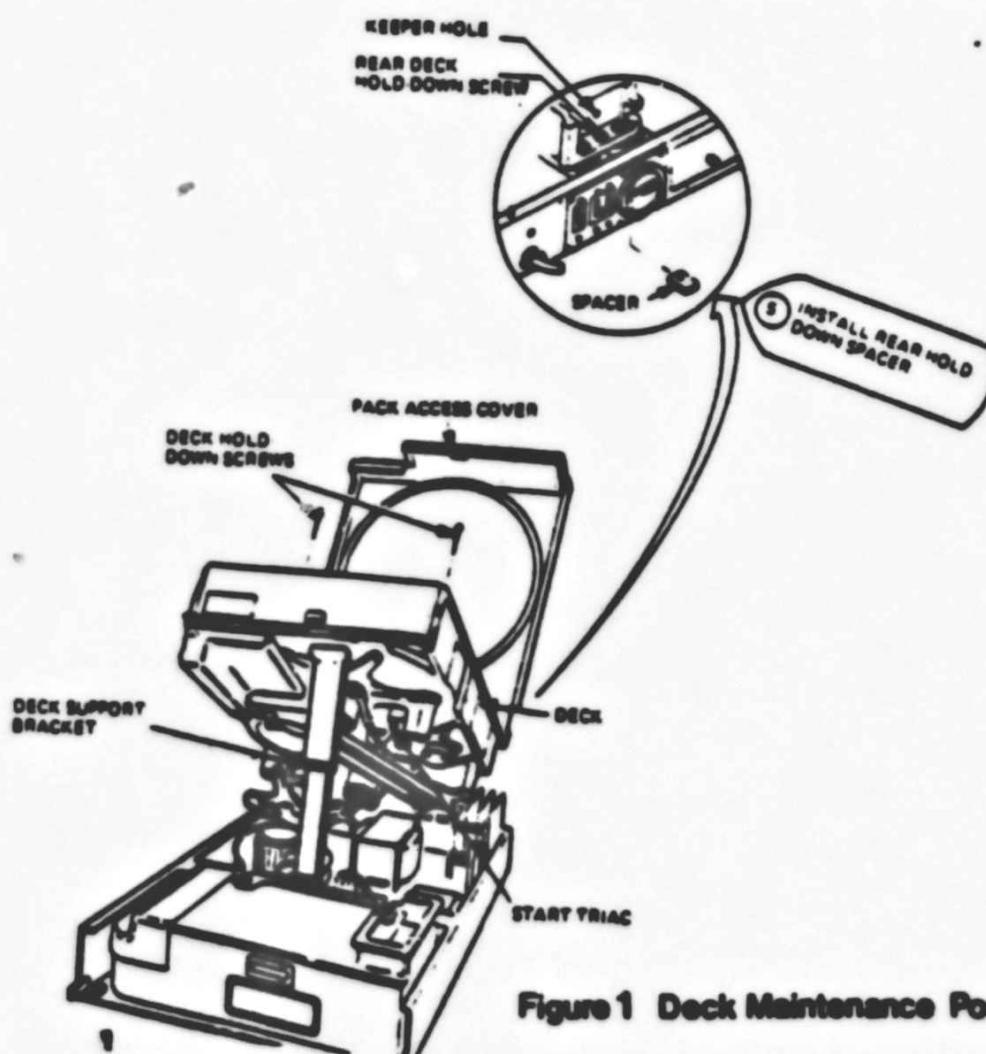
### Figure 1 Deck Maintenance Position

Failure/Symptoms: Possible start relay failure due to peak inverse voltages in excess of device rating.

This FCO replaces the existing 600 vclt A3K5 Start Triac (CDC P/N 94376501) with an 800 vclt Start Triac (CDC P/N 94376503)

3. Loosen the locking screws that hold the Drive top cover in place and slide it backwards off the Drive.
4. Install the heads actuator locking pin into the "shipping lock" hole to prevent the actuator from moving.
5. Install the rear deck hold-down spacer. (See Figure 1)

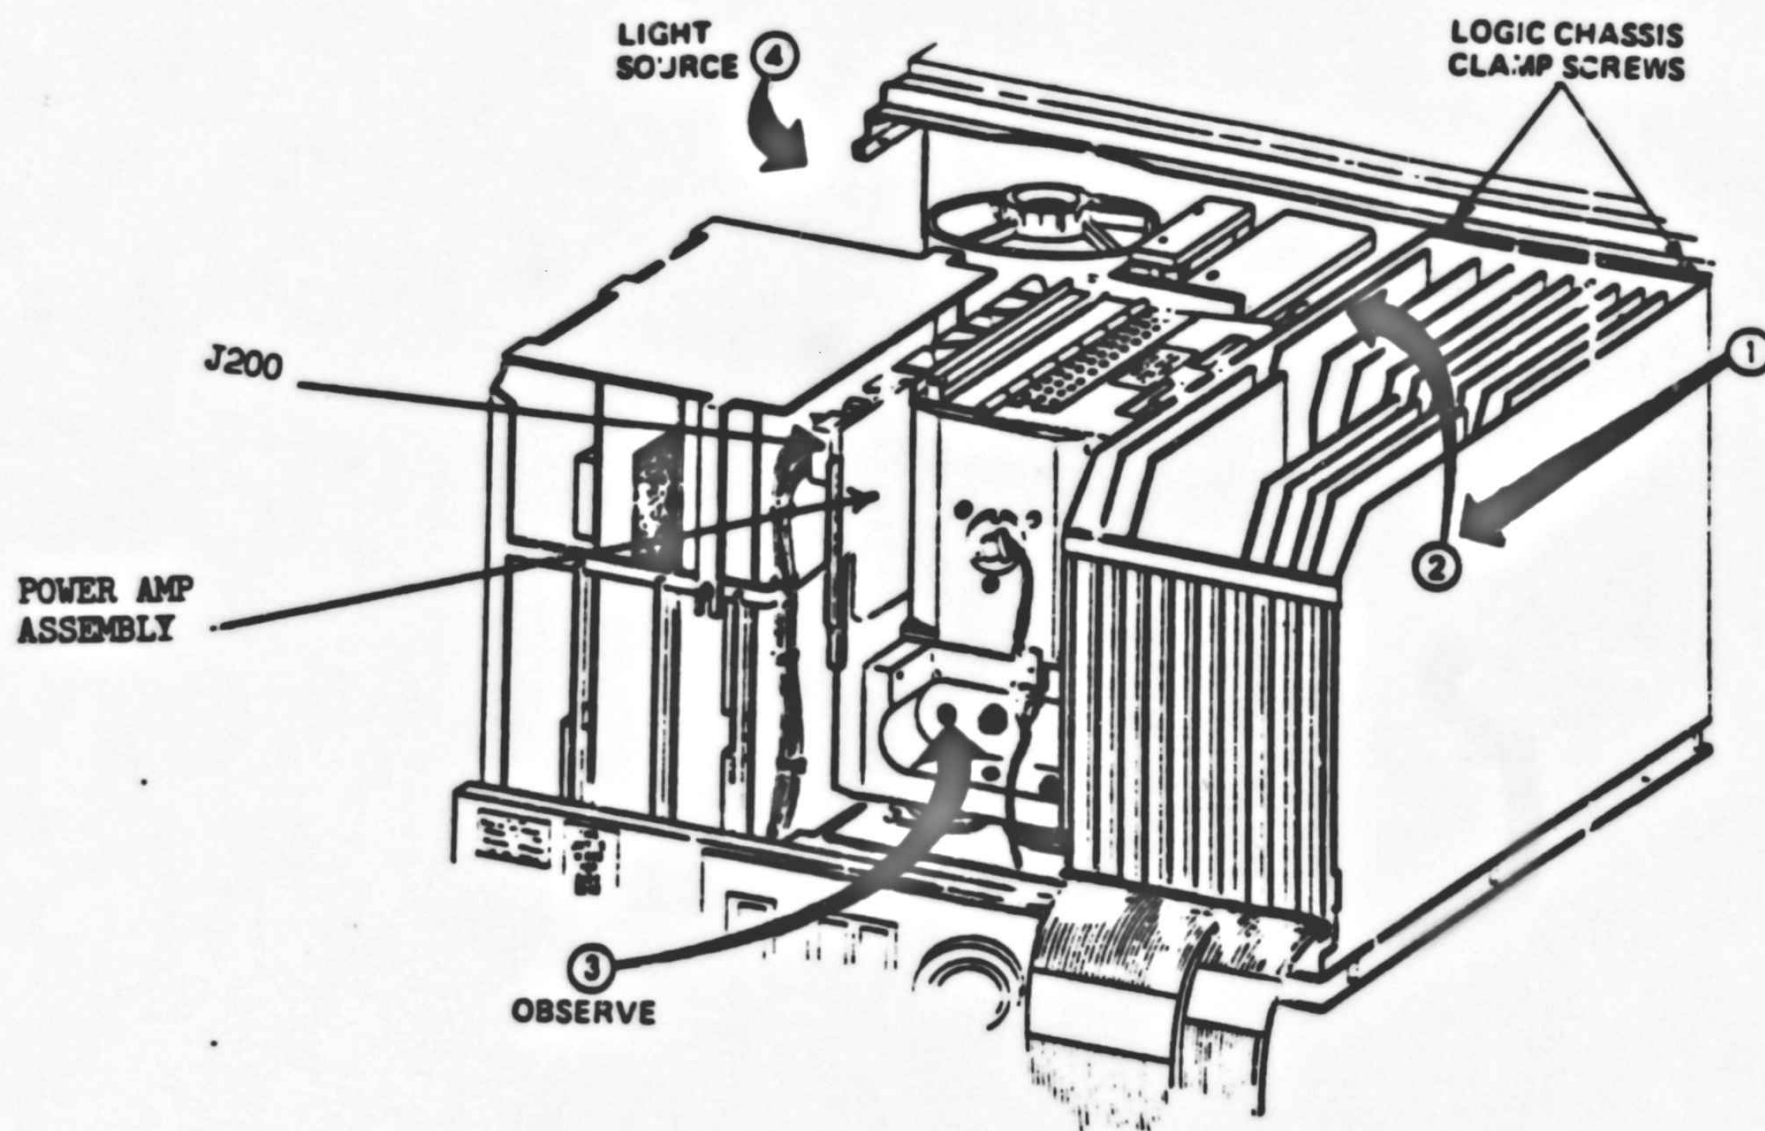
FIGURE 1

Problem/Symptoms: Transformer (A1T1) may come in contact with the upper deck plate assembly (when raised or lowered); resulting in damage to the transformer winding insulation and/or shorting of the transformer windings to the chassis.

4. Carefully slide the logic chassis (on its hinges) towards the rear of the drive and then up and to the left (counter clockwise) into the maintenance position (ARROWS 1 & 2 in FIGURE 1).

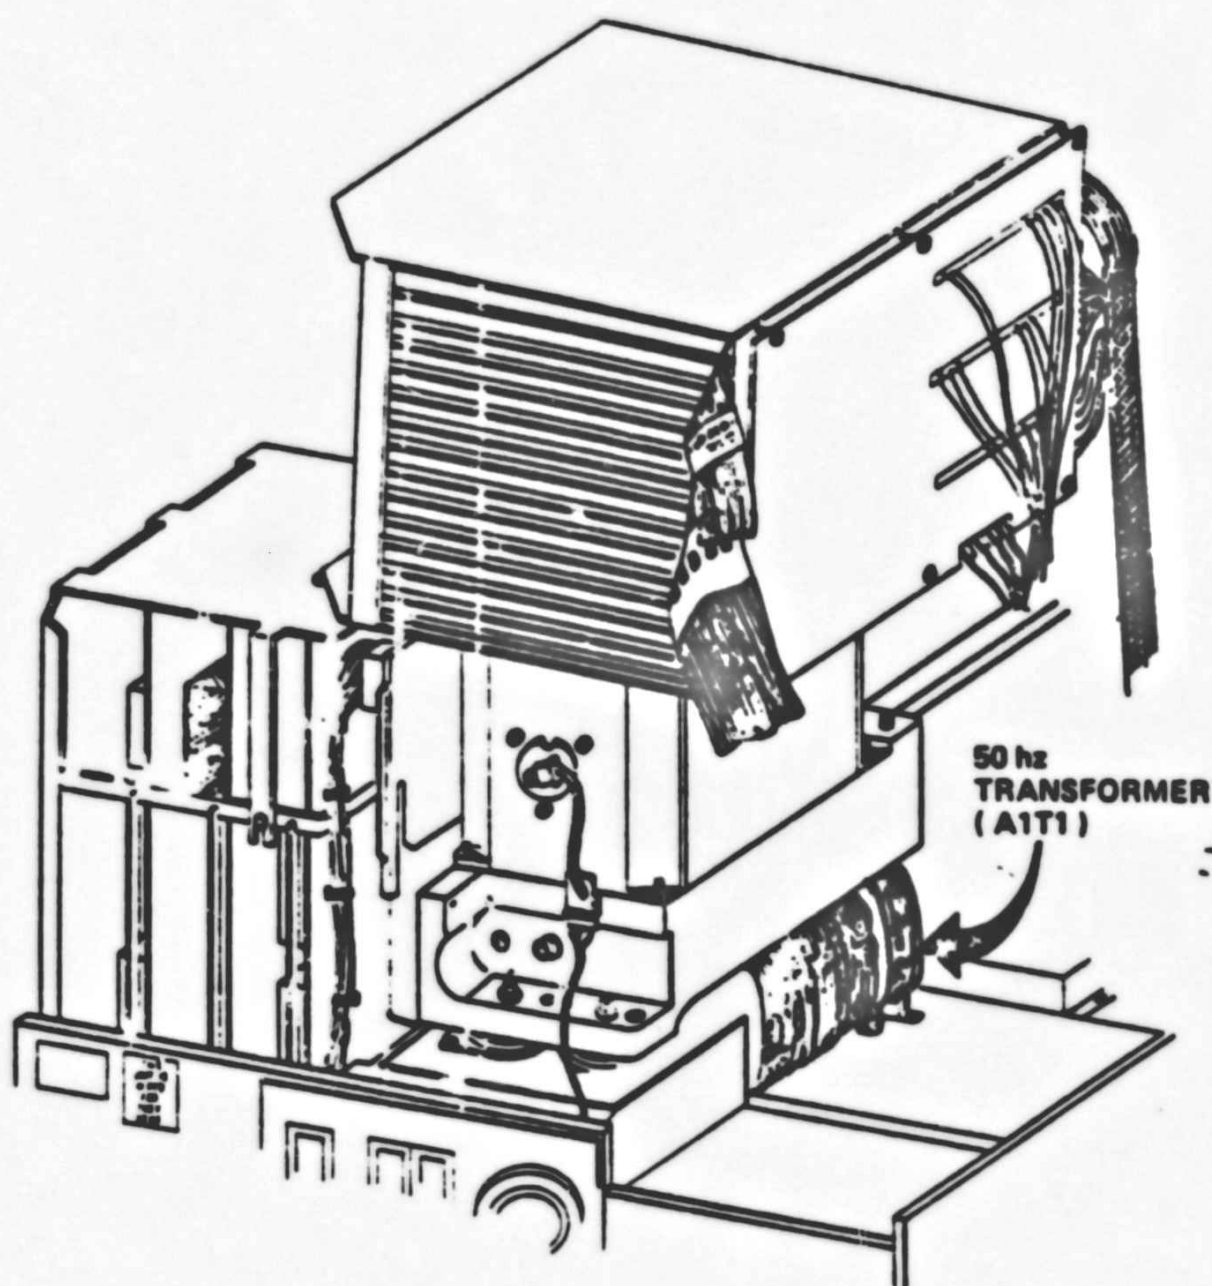
FIGURE 2

5. Locate the main (50HZ) Transformer (A1T1) as shown in FIGURE 2.

7. Carefully examine the insulation on both sides of the transformer (transformer windings insulation) for any signs of physical damage (ie: punctures, tears, scratches, indentations, etc.).

**IF PHYSICAL DAMAGE HAS OCCURRED THIS WILL REQUIRE REPLACEMENT OF THE TRANSFORMER. GO TO SECTION 2 FOR TRANSFORMER REPLACEMENT PROCEDURES.**

8. If there is no physical damage to the AC power transformer winding insulation, check to ensure that the required clearance between the AC power transformer winding insulation and the upper deck plate assembly is 2mm (.08 inches).

9. With the deck in its lowered position, check to be sure that there is a minimum clearance of 2mm (.08 inches), between both the left and right side of the AC power transformer winding insulation and any part of the upper deck plate assembly. The critical areas of clearance are noted by the arrows labeled with no. 5 in FIGURE 3. A flashlight and feeler gauge may be required. The side of the transformer closest to the power supply assembly, see FIGURE 4, can be observed by looking through the hole in the rear of the positioner (ARROW 3, FIGURE 1) and applying sufficient light (with a flashlight) as shown by ARROW 4 in FIGURE 1. Assure that there are no pinched wire harnesses and no chance of damage due to contact between the transformer assembly and the upper deck chassis or other surrounding components.

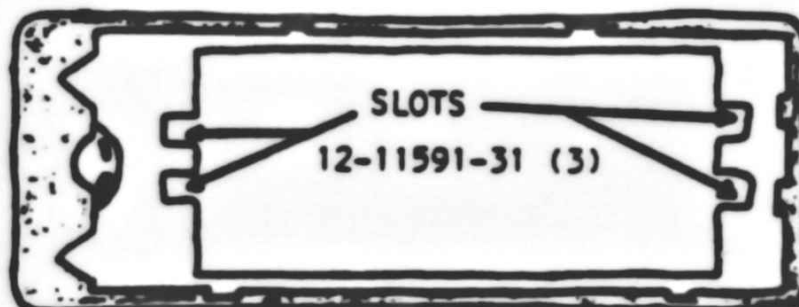
No  
Slots

BAD

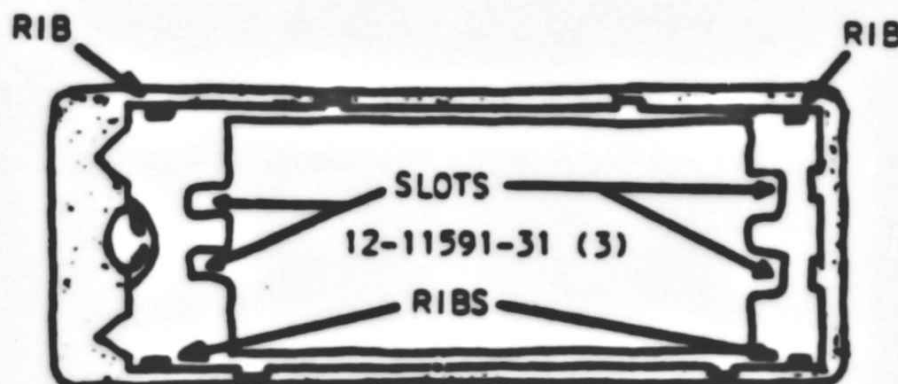
Slots  
NO RIBS

GOOD

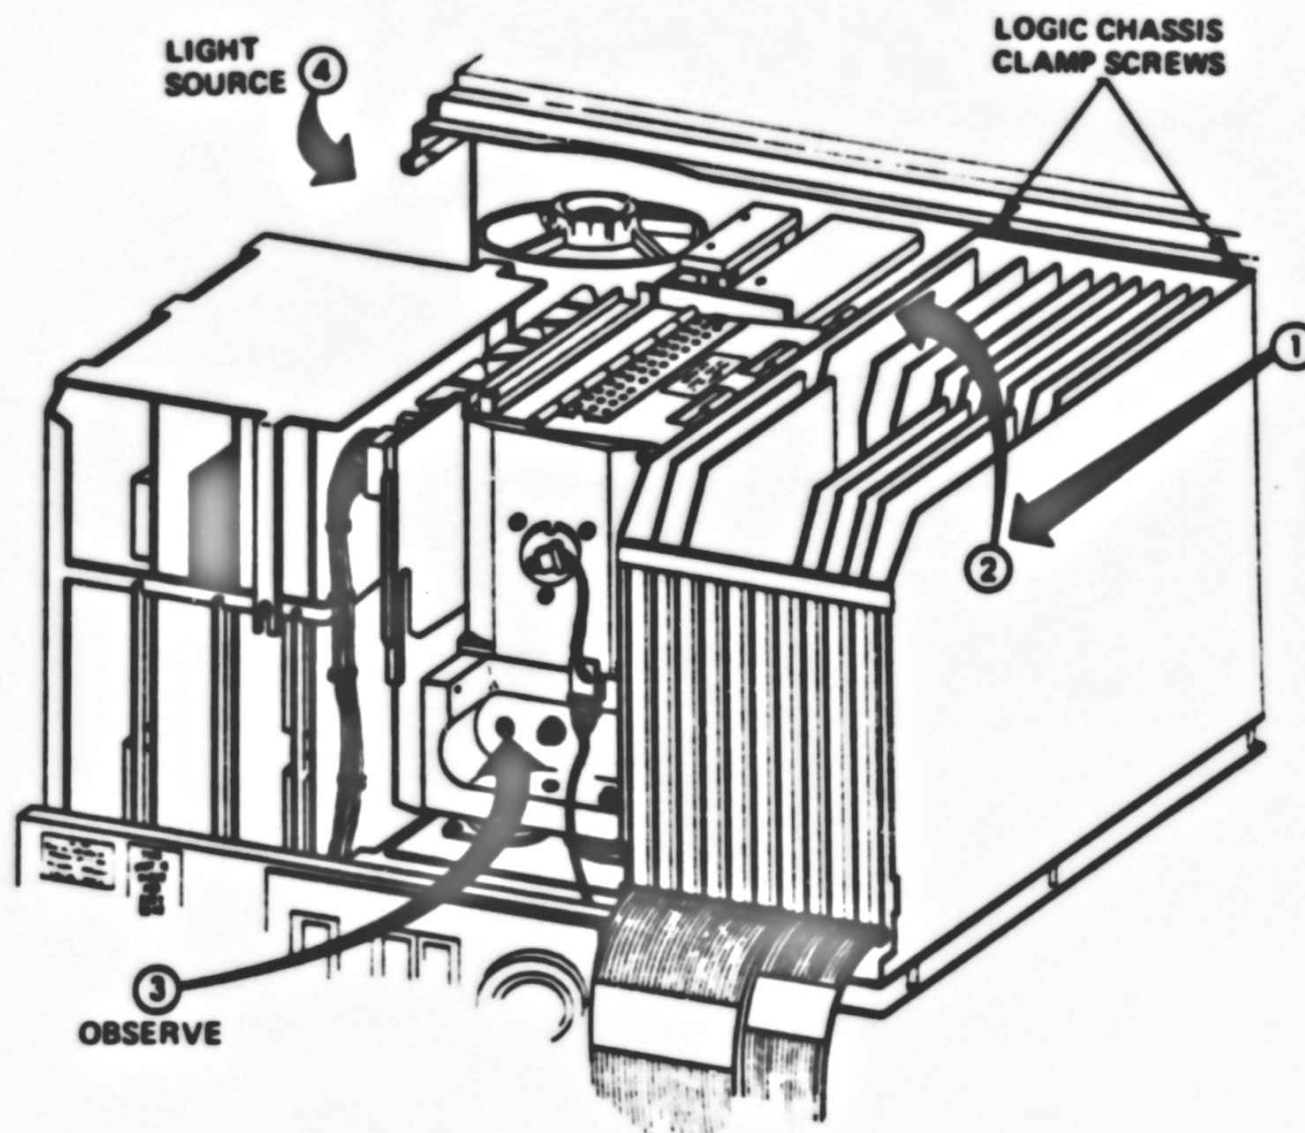
Fig. 1

| Title<br>50 Hz Power Transformer Shorting | | Tech Tip No.<br>RM03-TT-55 | |

- 1) Power down the drive and disconnect the AC power source.
- 2) Remove the top cover assembly.
- 3) From the rear of the drive, loosen the logic chassis clamp screws (see figure 1).
- 4) CAREFULLY slide the logic chassis (on its hinges) towards the rear of the drive and then up and to the left (counterclockwise) into the maintenance position (arrows 1 & 2, figure 1).
- 5) Locate the main 50hz transformer (A1T1) as shown in figure 2.
- 6) A closer view of the transformer is shown in figure 3.
- 7) The critical area of clearance is noted by arrow 5, figure 3. Check to be sure that there is sufficient clearance between the transformer and the upper deck chassis. A minimum of 2mm (.08") clearance is required. A flashlight and feeler gauge set may be required.

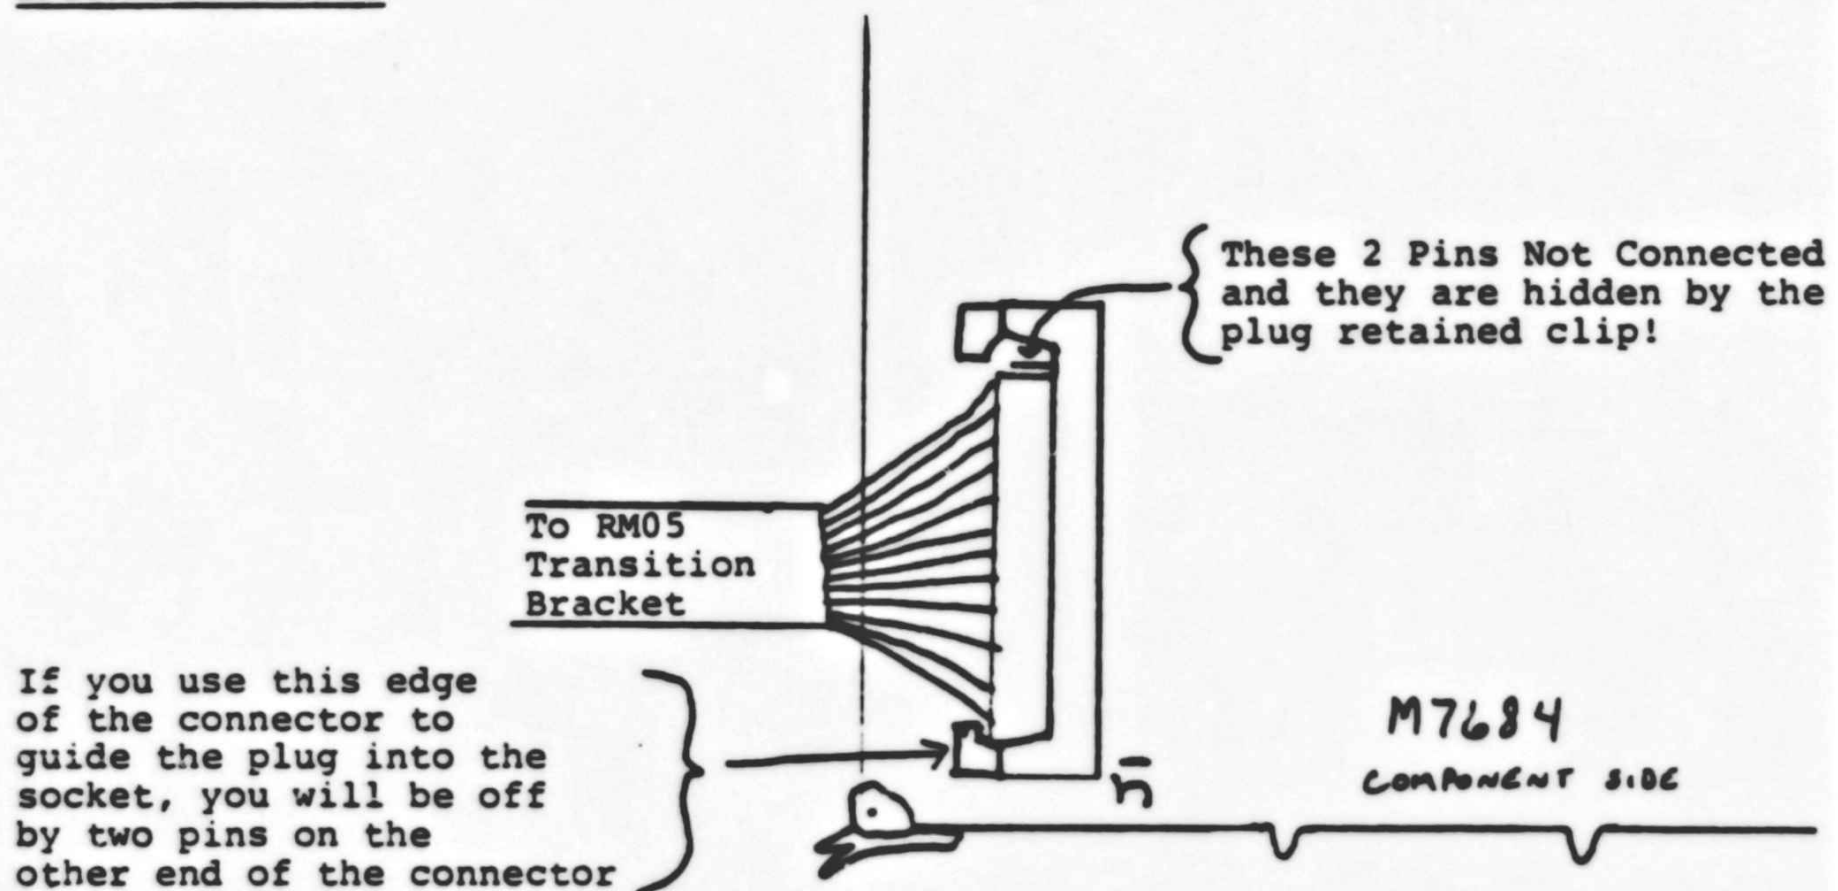
INCORRECT RESULT:

A problem exists between the AMP connector on the M7684 (J1) of the RM adapter, and its corresponding cable from the RM05 transition bracket. The problem is that the cable connector plug is narrower than the mating AMP socket on the M7684 (J1) board. This can result in the cable being plugged in two pins off. The proper connection of the cable is with all pins of J1 mated with the cable plug.

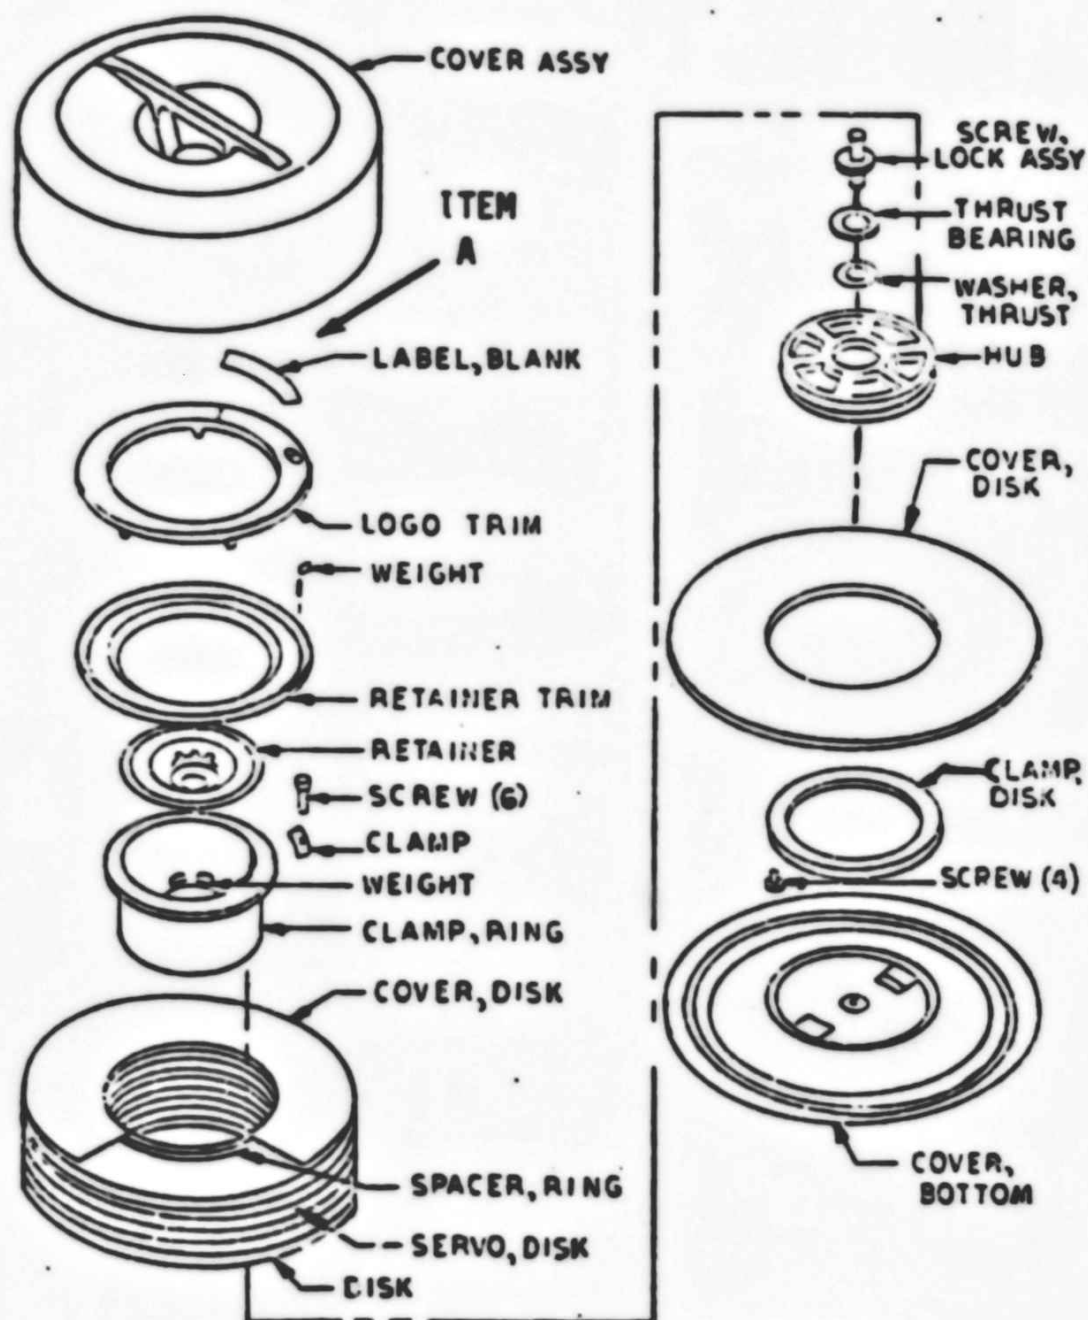
FIG 1, DISK PACK COMPONENTS

These labels are prone to release from the trim shield during spin-up cycles and could seriously damage the drive and/or heads.

CSSE and Engineering advise these labels be removed from all existing and new packs prior to installation into a drive.

An ECO is being written to have these plastic labels excluded from all future packs.
